— SUPERYACHT TENDER SUPPORT —

CUSTOM 4.3M NOVURANIA JK-7 VELSHEDA SUPERYACHT TENDER REFIT

SUPERYACHT TENDER REFIT | CUSTOM 4.3M NOVURANIA

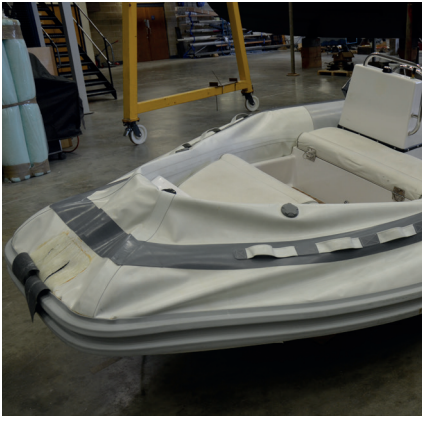
A simple inspection showed that both the port and starboard chambers were compromised with a rip down both sides. Tube repairs were made to both the aft sponsons under the tube and the rubbing strake. Once tube repairs were complete it was given a full solvent wash making it look as good as new.

Tube damage to the bow

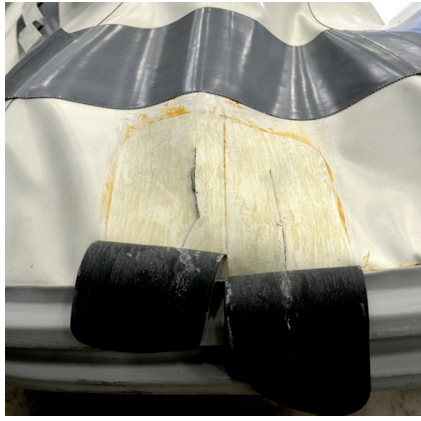
Bow tube damage

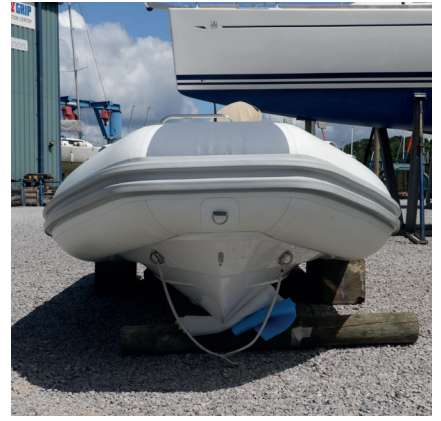
Bow tube repair

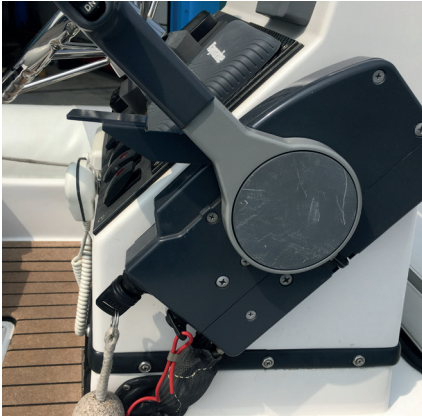
Part of the instructions from the Captain Engineer included the need to investigate throttle problems. Berthon's diagnosis was that the gears had excessive wear and other components were not functioning correctly. The in-gear anti-start mechanism was temperamental causing problems when starting the boat. Estimating the cost of repairs to the throttle system established that replacement would be a more cost-effective solution, and so a new modern 2016 Yamaha compatible unit was installed.

Worn out Yamaha Throttle

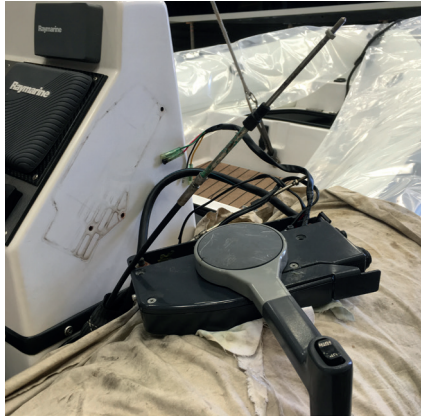
Removal of the throttle

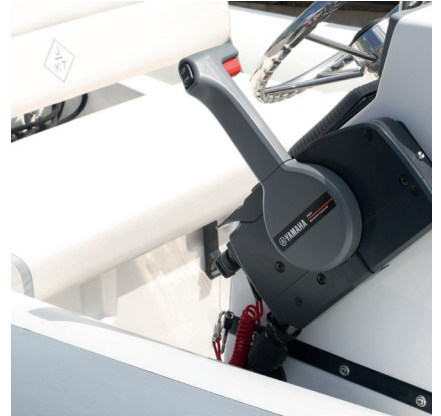
New Yamaha Throttle in place

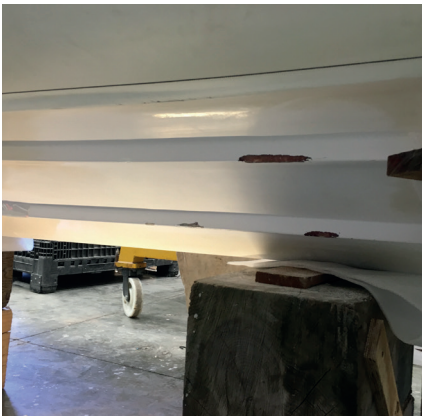
Where the RIB had been repeatedly beached the gelcoat was understandably worn and damaged; these areas were carefully ground back, and matched-colour gelcoat was applied and sanded. UV light and pollution had taken its toll elsewhere, so all the gelcoat both above and below the waterline was cut and polished to create a uniform original colour with repairs imperceptible.

Hull damage After Beaching

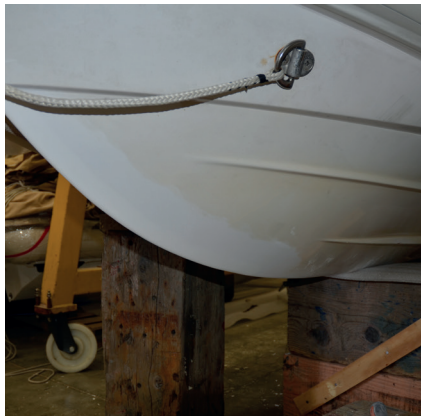
gelcoat showing repairs

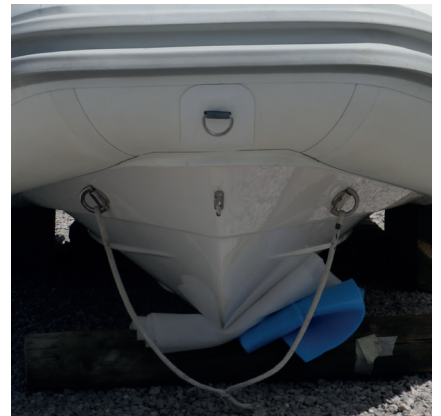
Polished gelcoat repair

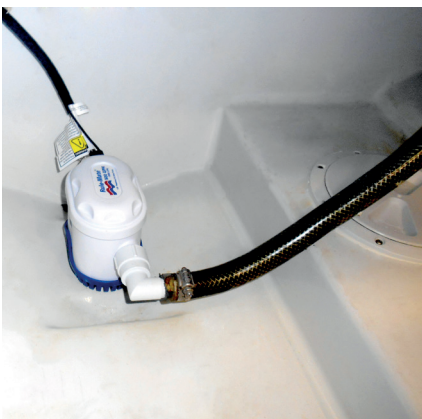
The crew were aware that water was penetrating the hull, and requested two inspection hatches that allowed swabbing the little amount of water left after the new automatic bilge pump we had installed had operated.

new bilge pump

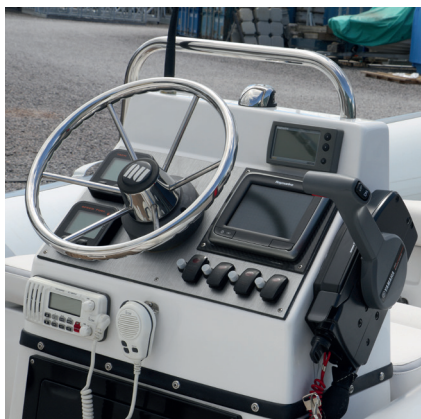
Console cleaned and polished
