CUSTOM YACHT REFIT

Aglia, a 77ft 15-year old yacht designed by Rob Humphreys, was sold by Berthon in the autumn of 2015. The new owner wanted her refitted and modernised; accordingly, a delivery crew brought her north to Berthon's Lymington Shipyard in October 2015. This is the story of her comprehensive restoration, a project that spanned just 9 months and was completed entirely at Berthon.

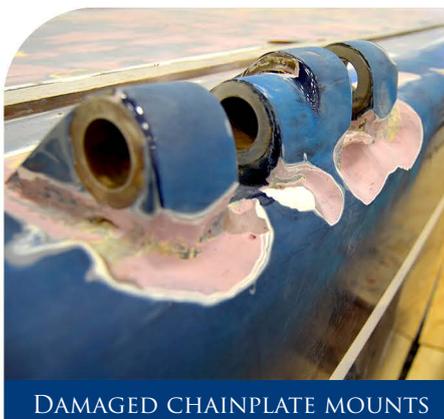
DAMAGED CHAINPLATE MOUNTS

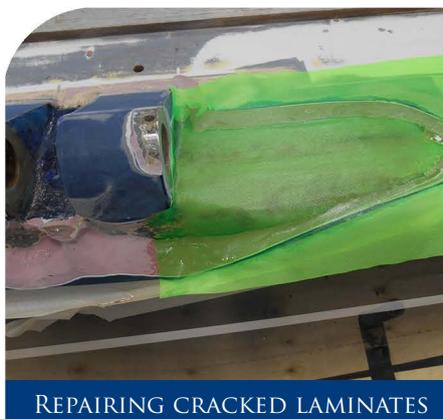
REPAIRING CRACKED LAMINATES

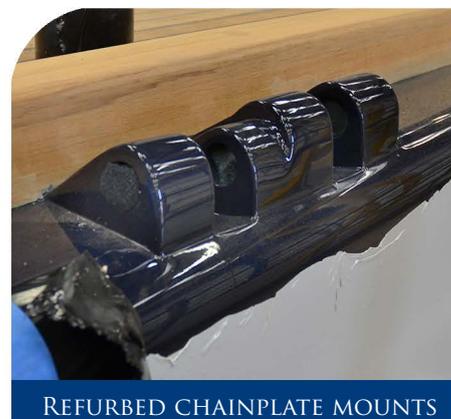
REFURBED CHAINPLATE MOUNTS

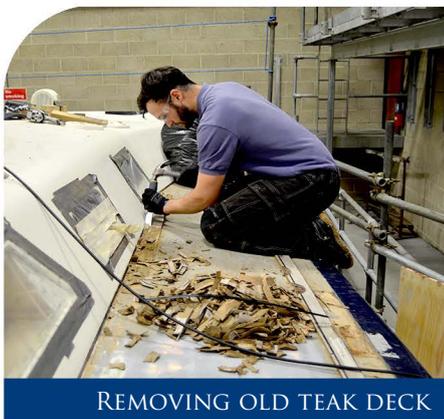
REMOVING OLD TEAK DECK

The deck was found to be only 7mm thick, on average, having suffered the wear and tear of 15 years at sea in largely tropical climates; the elements and years of cleaning had clearly taken their toll. The teak area was templated, the toe rail was lifted in one piece and the old deck carefully removed. Where the subdeck was found to be damaged in places, this was repaired in-situ. The new teak deck sections were laid on a fibreglass composite skin and, using an epoxy adhesive, it was glued to the subdeck with no through-deck fixings to prevent water leaks. Berthon custom-made a new teak toe-rail.

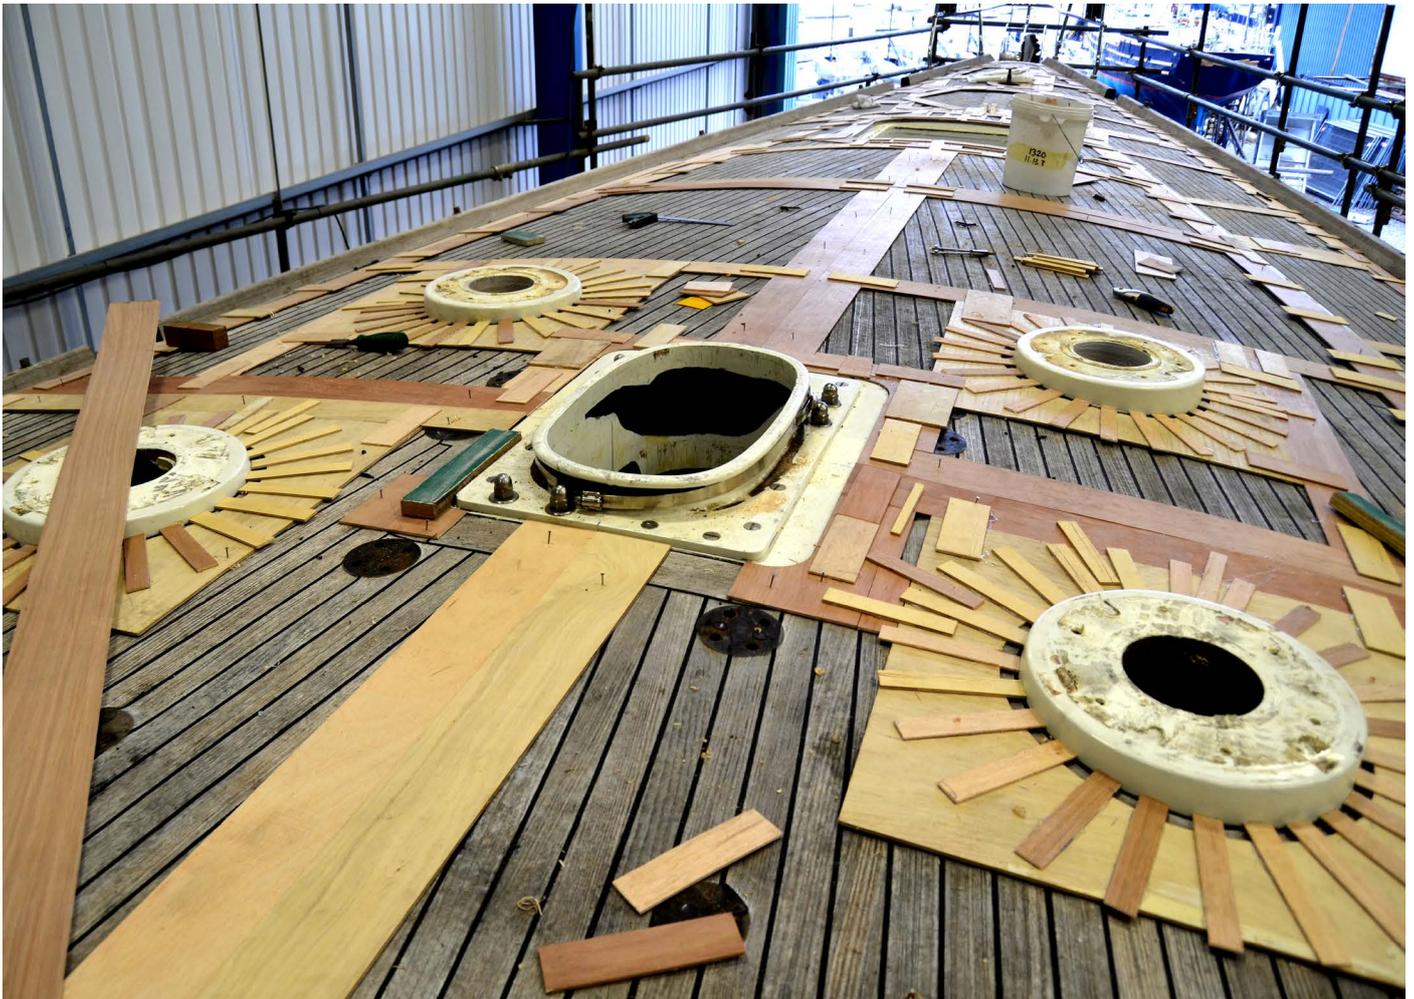
TEMPLATES FOR THE NEW TEAK DECK

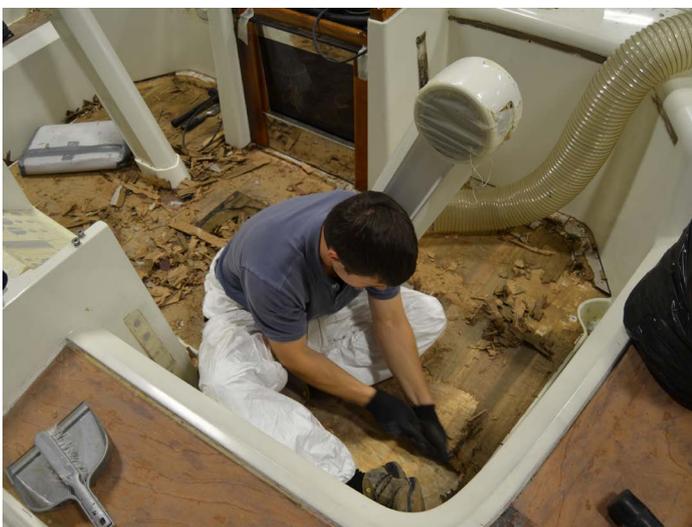
REMOVING THE OLD TEAK DECK

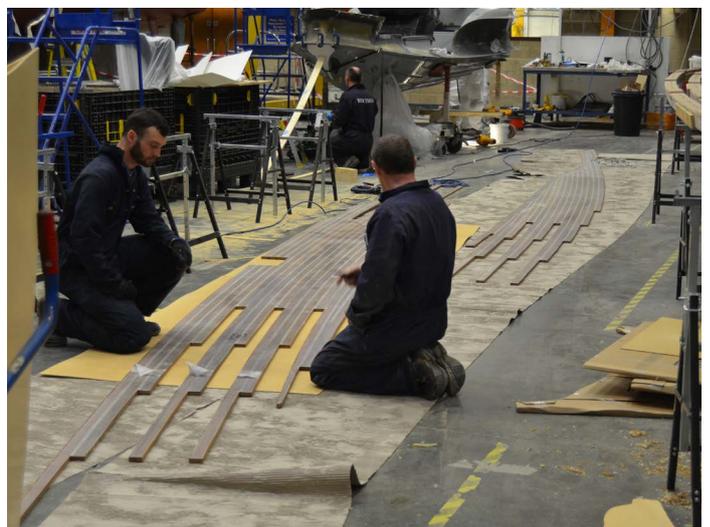
NEW TEAK DECK LAID OUT

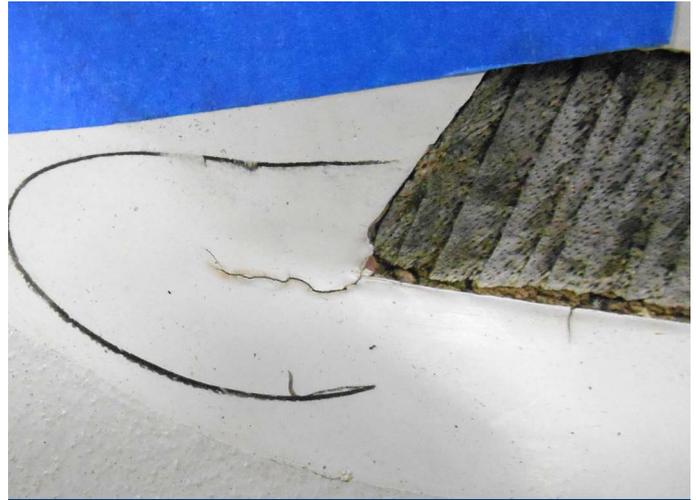
On close inspection, the doghouse structure was showing signs of wear with cracks appearing at the base of the mullions which were repaired and reinforced in-situ. Whilst simultaneously strengthening the mullions so that they could better support the roof, the structure was given a modernising facelift altering the previously white mullions to match the black windows, which improved and modernised its visual profile. The windows were replaced using reinforced acrylic to help resist scratching and further reduce the overall weight.

CRACKS ON THE MULLIONS

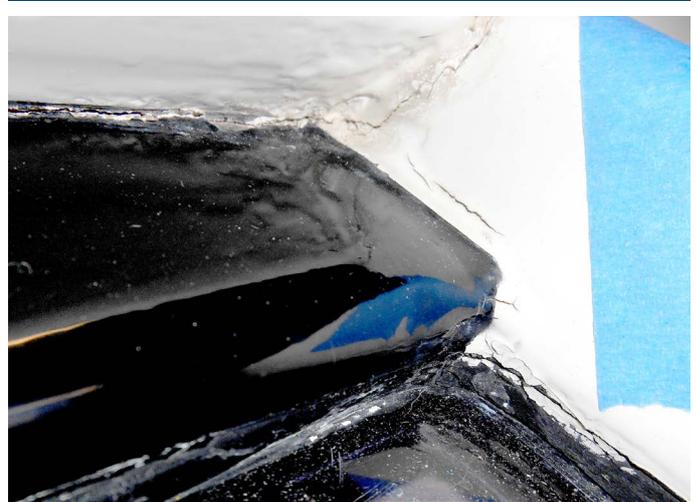
CRACKS IN THE DOG HOUSE STRUCTURE

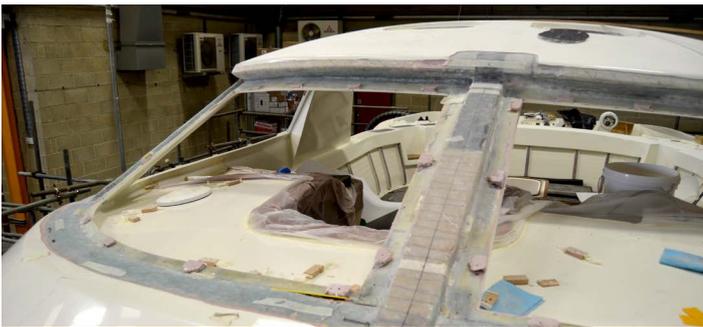
REINFORCED DOG HOUSE WINDOW MULLIONS

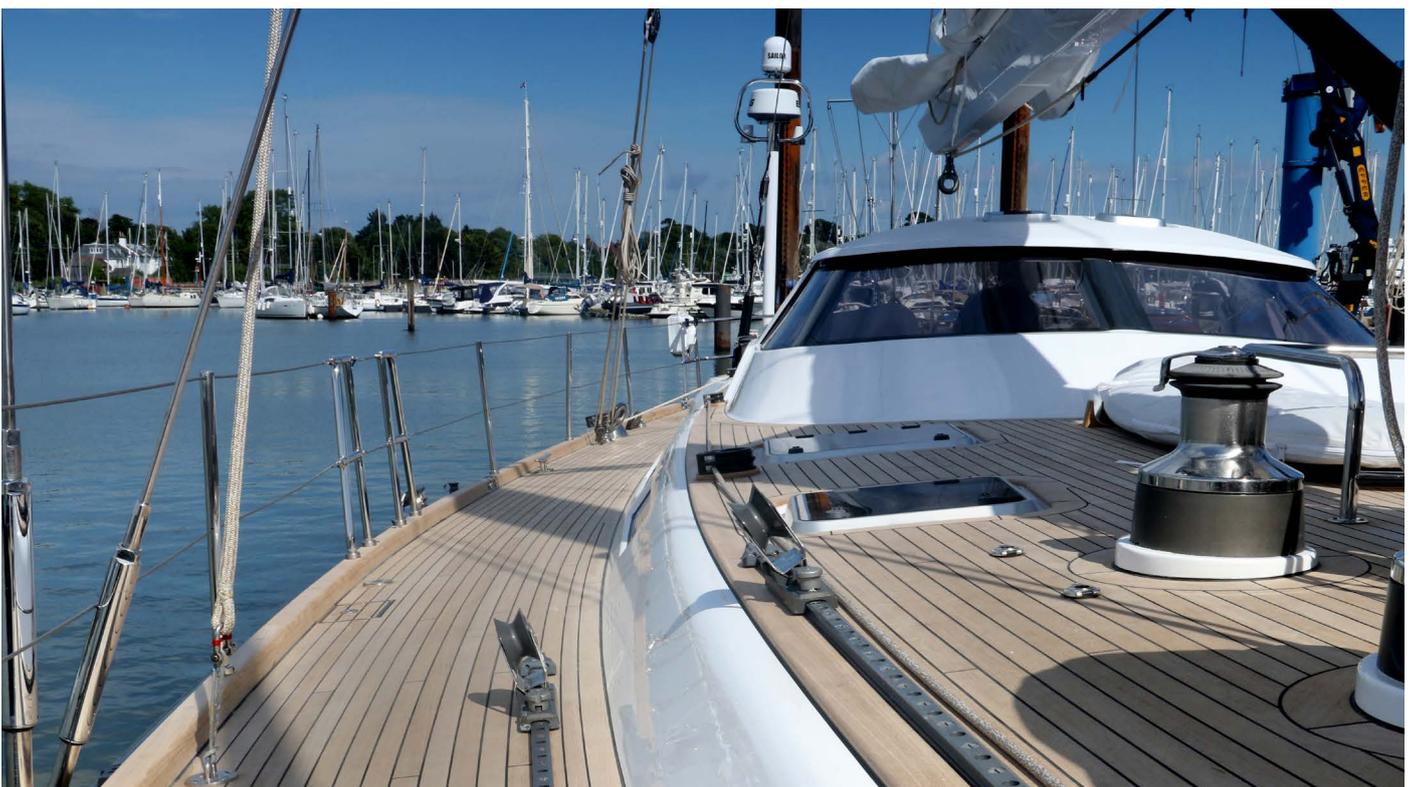
NEW DOG HOUSE MULLIONS BLEND SEAMLESSLY INTO WINDOWS

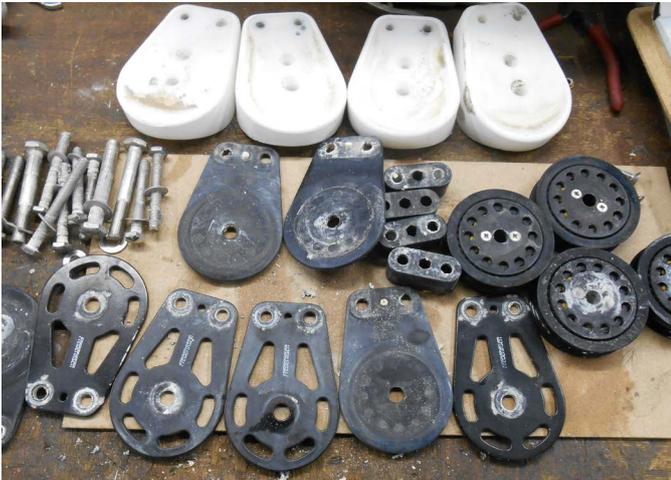
ORIGINAL DECK BLOCKS & GEAR

Deck blocks and deck gear were taken up to be serviced, cleaned and renovated in Berthon's engineering workshop whilst the new teak deck was being laid. There were over 300 constituent parts to the deck. All the bolts were changed over to A4 high-grade marine stainless steel, to extend the life of the fixtures. New Lewmar 66 winch bases were installed and teak deck chocks were fitted amidships for a new windsurfer, as well as on a Berthon custom built stainless cradle for the new Williams 3.85 Jet tender on the foredeck.

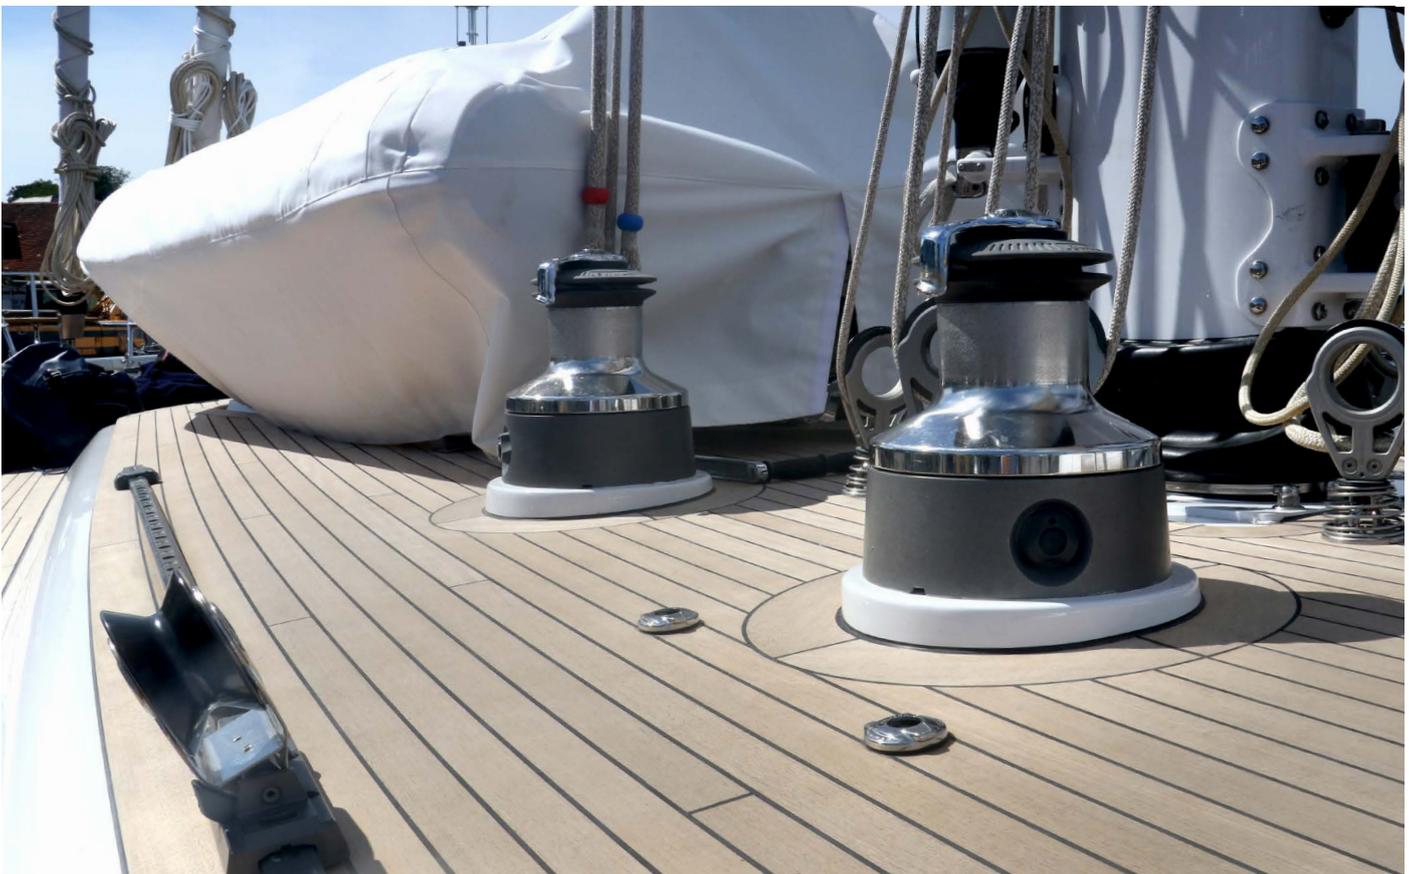
SERVICED, CLEANED AND REFURBISHED DECK BLOCKS & GEAR

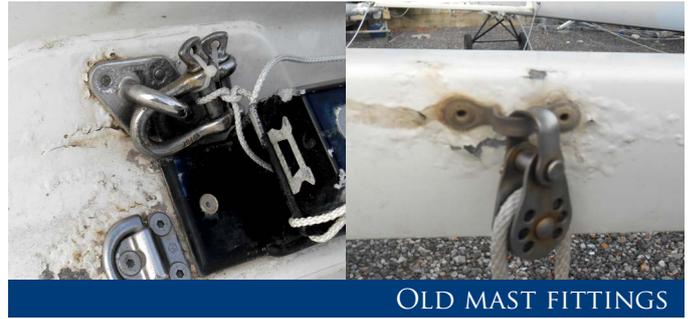
OLD MAST FITTINGS

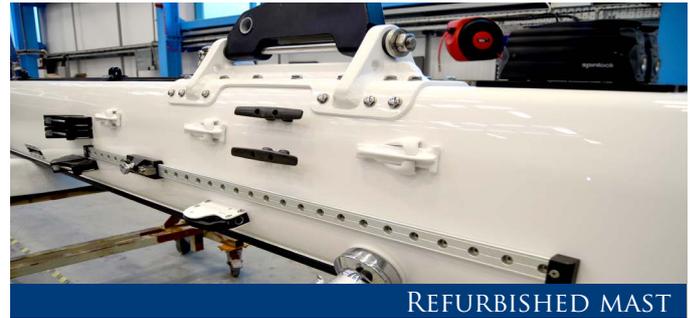
REFURBISHED MAST

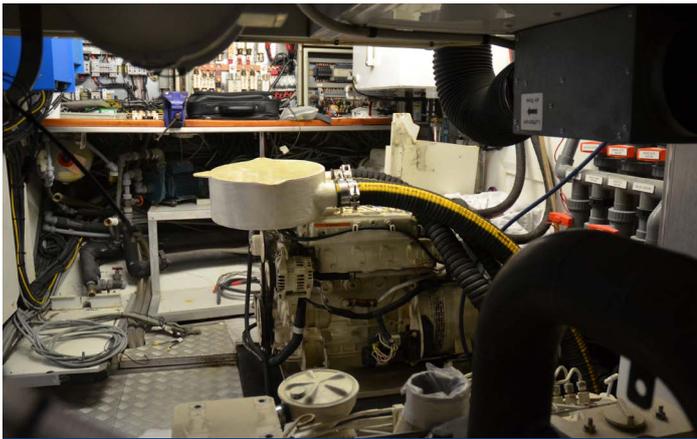
ORIGINAL ENGINE ROOM

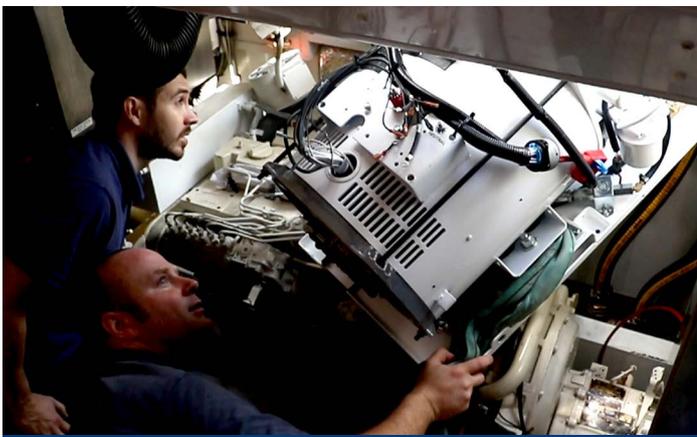
INSTALLING THE NEW KOHLER GENERATOR

A new Kohler generator was installed and during the engine service and specialist exhaust advice was sought from internationally renowned Halyard Marine. The bilge pump systems were completely overhauled, as was the air conditioning, ventilation system, fuel system and filters, hydraulic system and grey/black and freshwater systems were serviced and upgraded where the owner felt it necessary. The work was all completed in-house by Berthon. Every through-hull fitting was serviced, along with a large numbers of sensors and senders that had failed or were not working over time.

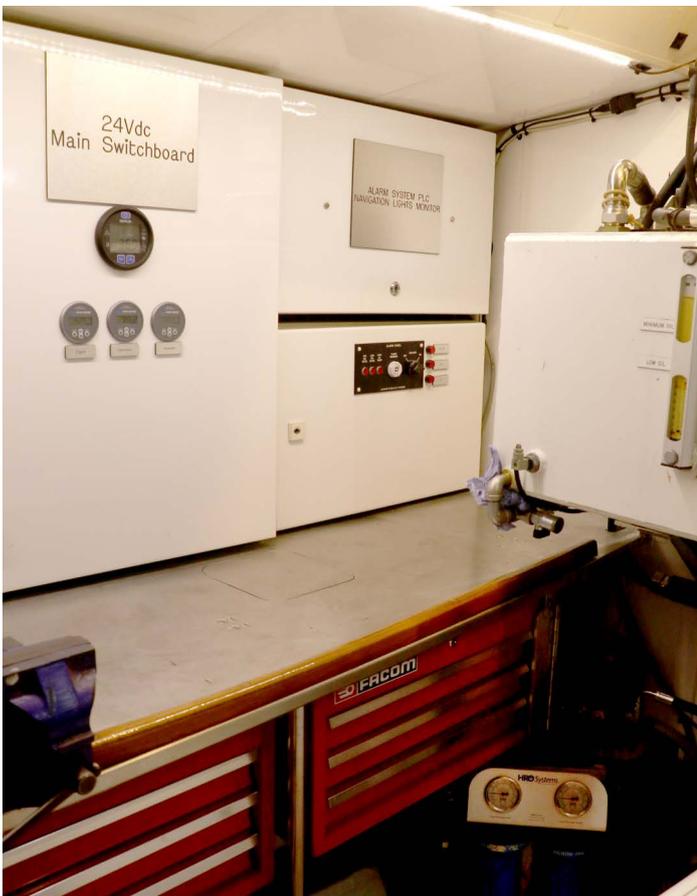
UPGRADED SWITCHBOARDS

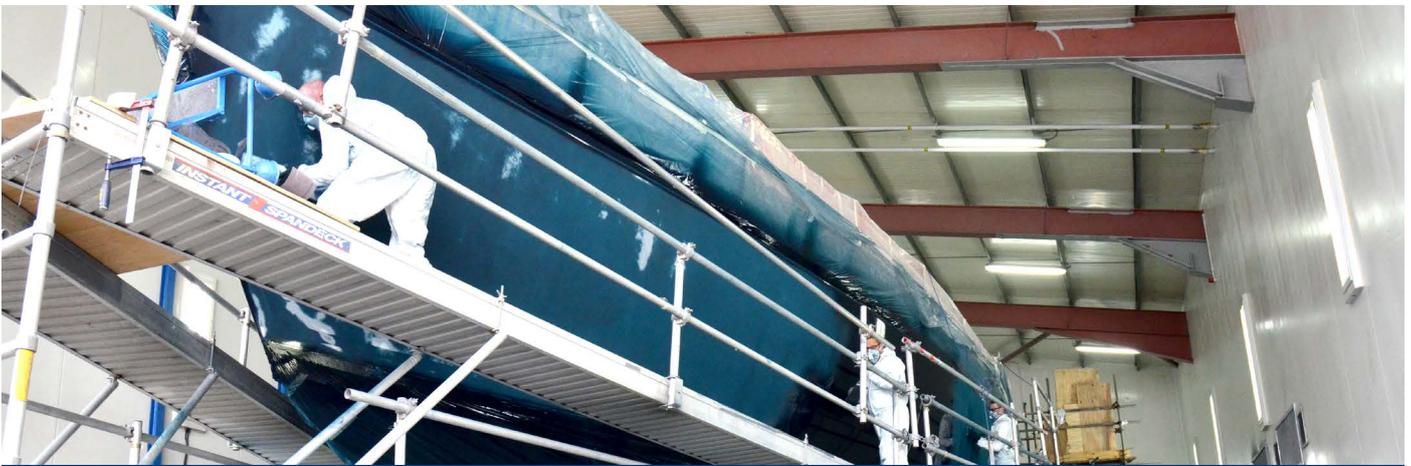
PREPARING AGLAIA FOR PAINTING

The topsides were tired; Aglaia spent many weeks in the paint preparation shed undergoing multiple hand sandings with longboards between various coats of Awlgrip highbuild and primer to achieve a perfect preparation surface for the final gloss coatings. Aglaia was then moved to Berthon's glossing booth which is kept void of dust, where topcoats were applied to hull and coachroof and coaming areas using Awlcraft 2000 in Majestic Blue Gloss and Snow White Gloss respectively.

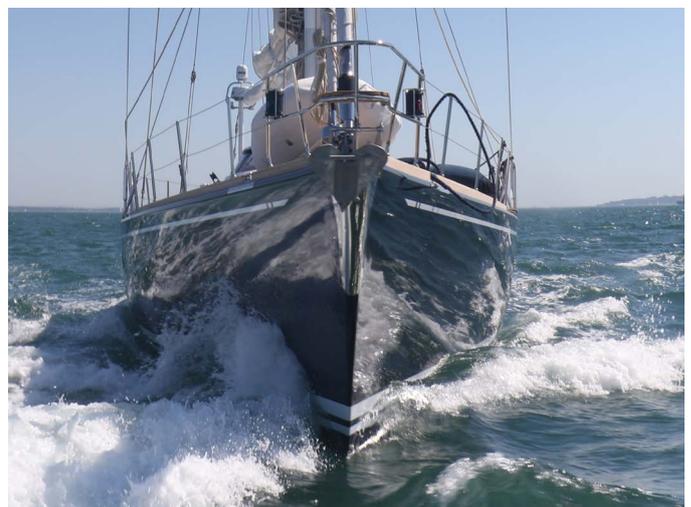
MAJESTIC BLUE & SNOW WHITE CUSTOM PAINT FINISH

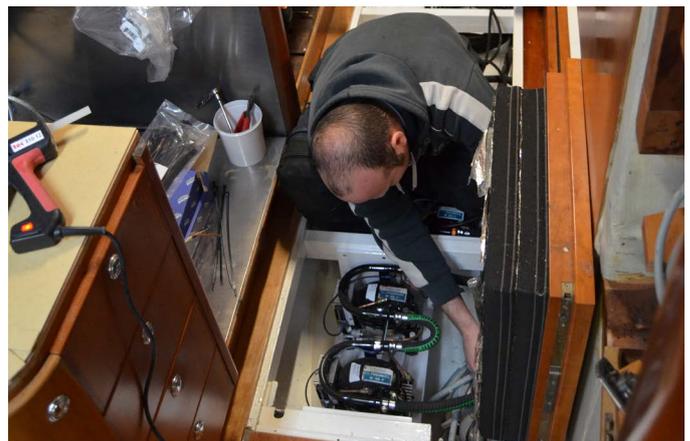
NEW REFRIGERATION COMPRESSORS

We removed two of the old, inefficient fridge freezers replacing these with two new custom fridge freezers that were sourced and made in Italy, replacing all the plumbing, compressors and control system at the same time making Aglaia 'greener' and more energy efficient.

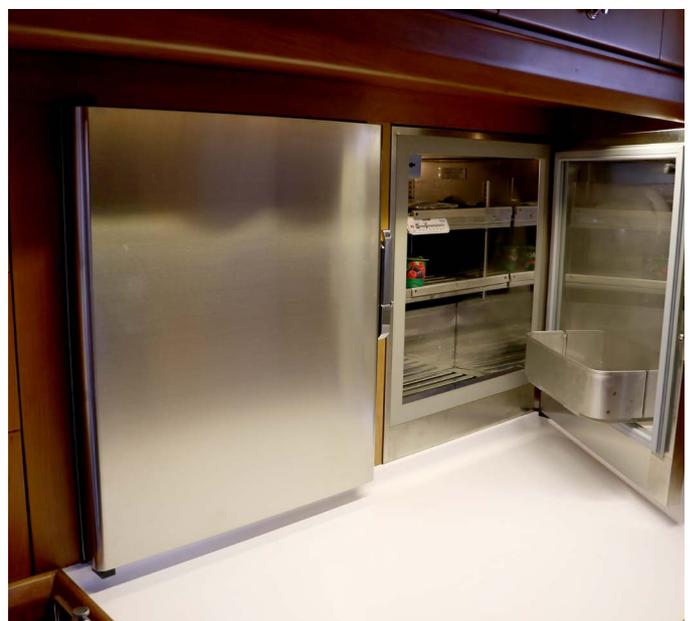
NEW ENERGY EFFICIENT CUSTOM FRIDGES

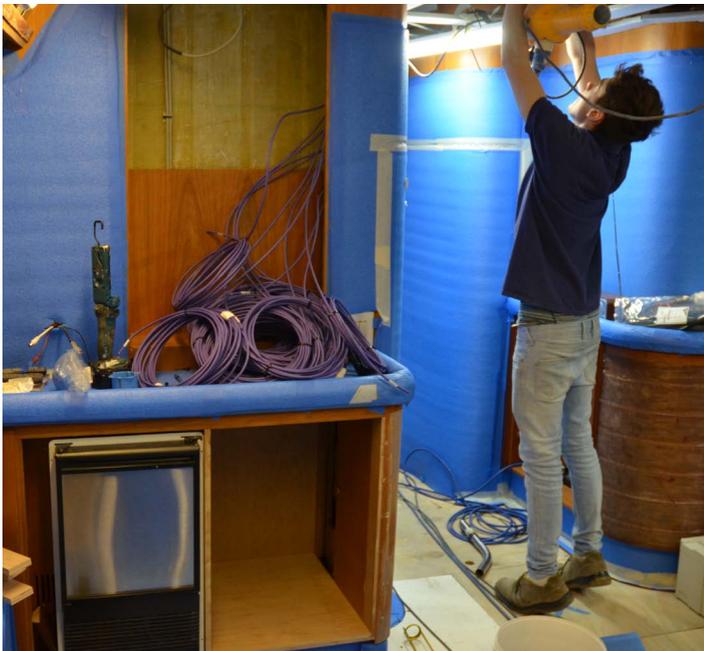
REWIRING AGLAIA'S ENTERTAINMENT SYSTEMS

Berthon was able to completely modernise the interior, incorporating technologies that have become ubiquitous in modern life, rewiring of the yacht to accommodate a new Cisco wireless network systems for 4G connectivity throughout. This part of the refit involved partnering with some of the coolest brands in media entertainment systems such as Cornflake of London, who provided a bespoke sound system, mirroring the owner's home set up. New hardware included Sonos speakers that were fitted seamlessly into the headlining and cabinets and Apple iPhone and iPad docking stations all making storage of technology safe at sea, simple and stylish.

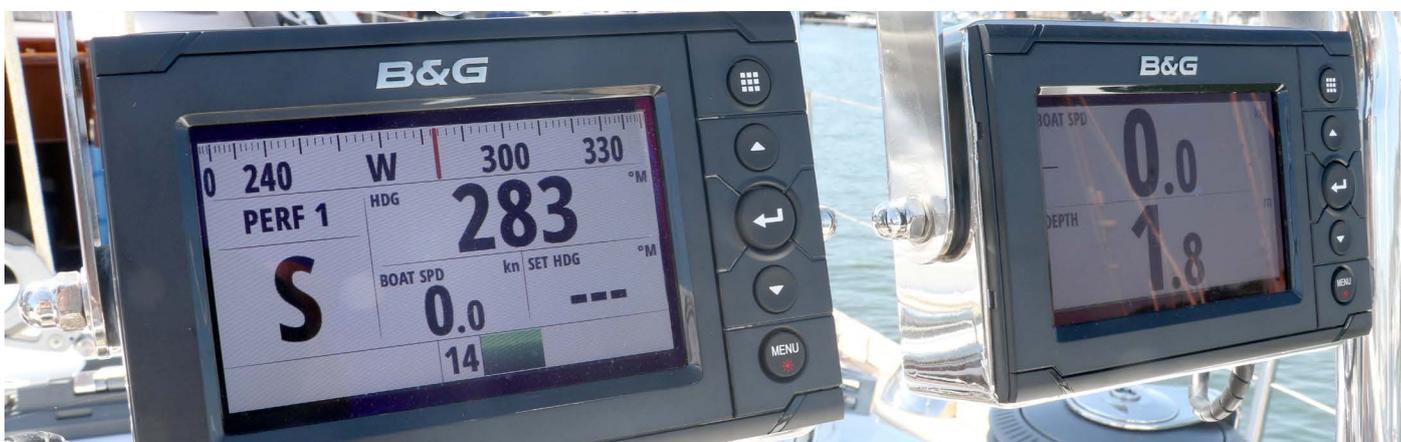
B&G INSTRUMENTS AT BOTH HELMS IN BERTHON'S CUSTOM MADE STAINLESS STEEL FRAMEWORK
