— SUPERYACHT TENDER SUPPORT —

6M PASCOE SUPERYACHT TENDER REFIT

SUPERYACHT TENDER REFIT | 6M PASCOE

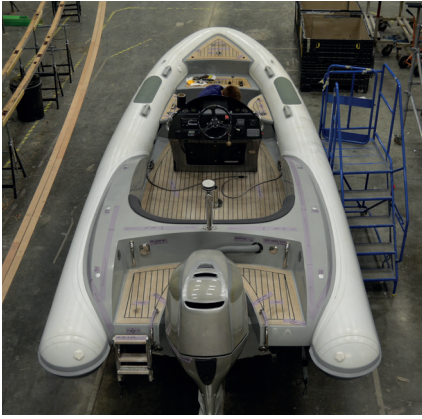
Boat ready for inspection

The tender arrived at Berthon for a full refurbishment and refit. Initial work included removal of the engine, the inflatable tube, and all of the deck fittings in order to assess the condition of the hull skin and composite structure.

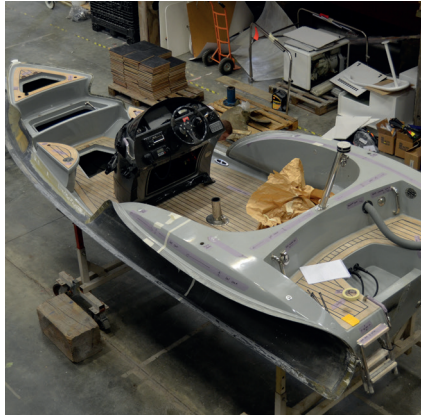
Stripped and ready for work

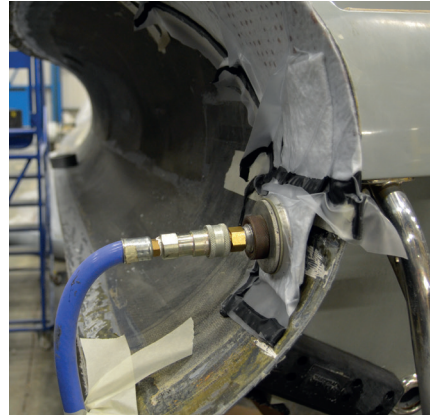
Structural repair to tube

Over the years the inflatable tube had suffered from ultraviolet degradation and abrasion damage in high-wear areas. The client had requested a number of functional improvements to the tube design, so alongside an update of the cosmetic design, a completely new replacement tube was manufactured and fitted immediately after painting.

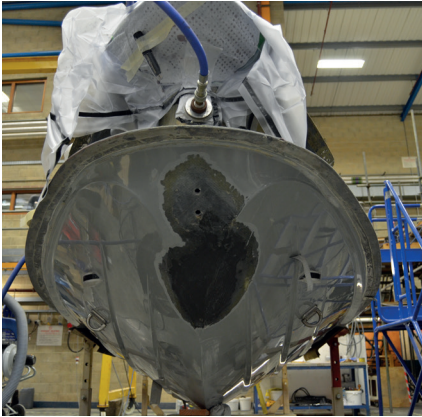
Hull showing damage

A full survey of the carbon fibre hull and deck structure revealed a number of areas of impact damage. Access was gained by the removal of major structures and the damaged areas were ground out. A mould was set up and plies of carbon-fibre reinforcement were vacuum-formed with a high-performance epoxy laminating resin. With repairs complete and post-cured to achieve the desired mechanical properties, the external surfaces were finished with a tie coat and polyester gel coat to match the surrounding gel coat finish. On completion, the repair was undetectable and this additional work was completed within the original project timescale.

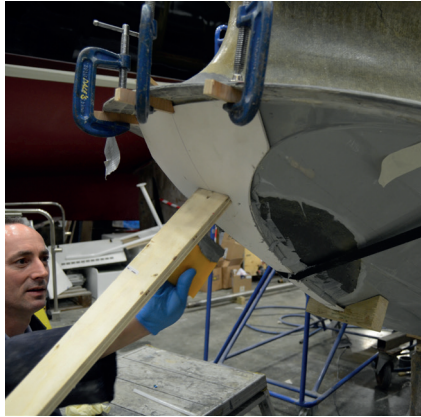
Repair of composite layer

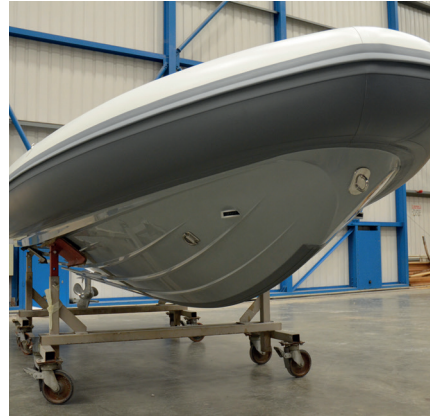
Looking as good as new

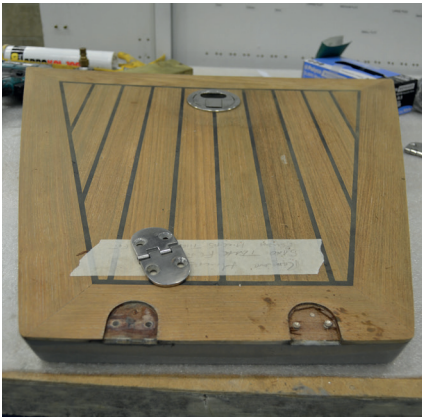
Assessment of the teak decks

The teak deck was heavily weathered and discoloured. The teak was rejuvenated by careful sanding to return it to its original colour and the seams with damaged caulking were re-payed. With such a lightweight minimal thickness deck covering, this operation had to be undertaken with the utmost care, otherwise the life expectancy of the deck would be seriously reduced.

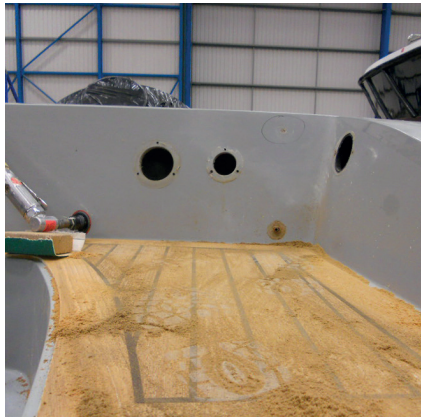
Careful sanding of the teak

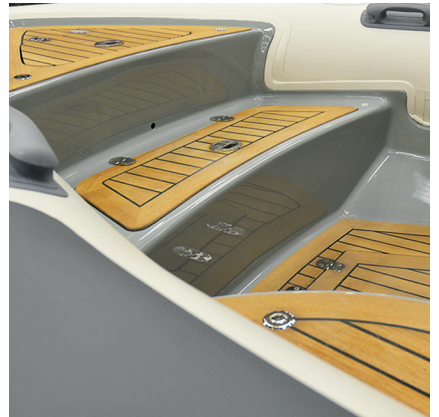
Teak in pristine condition

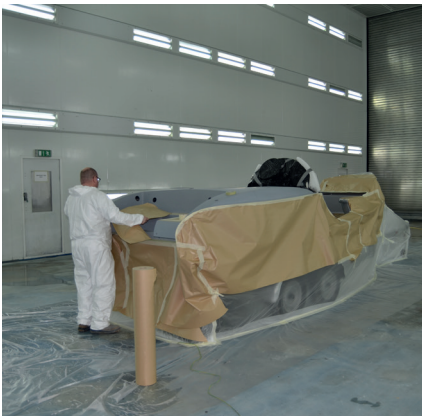
Preparation for painting

The decks, cockpit and superstructure were rubbed down, and minor repairs were filled and faired. Following application of an epoxy primer, multiple coats of Awlgrip topcoat were applied to provide a high gloss superyacht finish with good depth of colour.

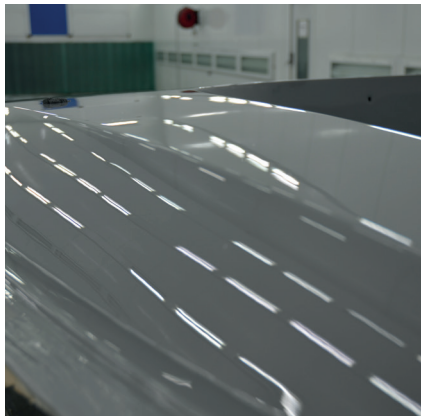
The first coat of Awlgrip

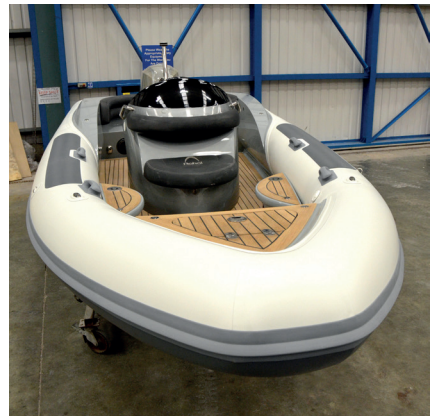
The finished article

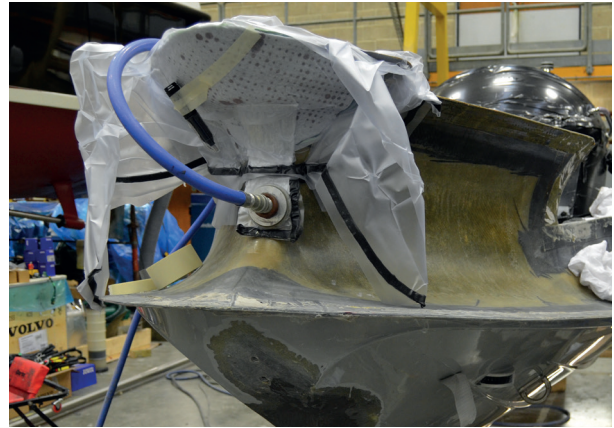
Consolidation of carbon repair

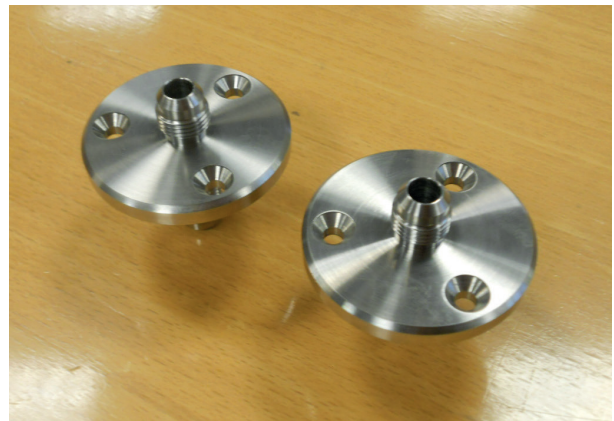
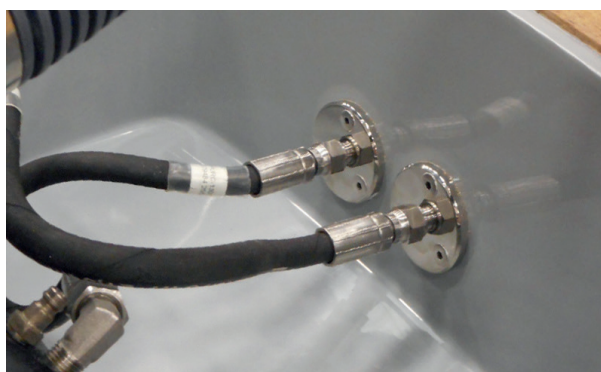
Customised bulkhead fittings

It is common to find that the sections of steering hose (which are exposed to sunlight) suffer from deterioration from ultraviolet radiation and wear and tear with repeated flexing every time the steering is used, or motor tilted. Berthon engineers manufactured specialist stainless steel bulkhead fittings for the transom, to separate the external hose from the internal hose which is hidden in a duct. A complete boat set of replacement steering hoses were manufactured and installed. This modification will, in future, enable simple replacement of the external outboard hoses when required.

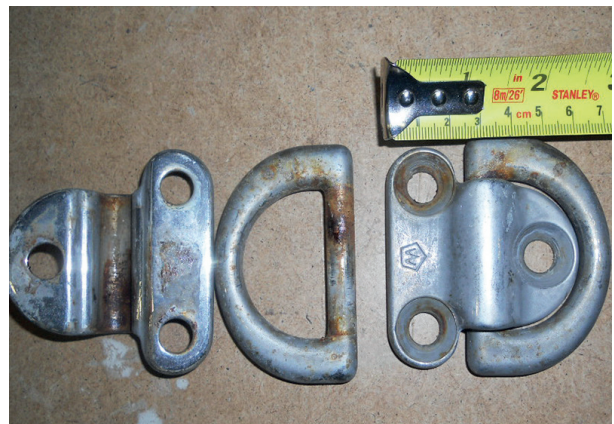
Towing eyes ready for polishing

All the fixtures and fittings were removed from the deck and polished, with worn or damaged parts being replaced.

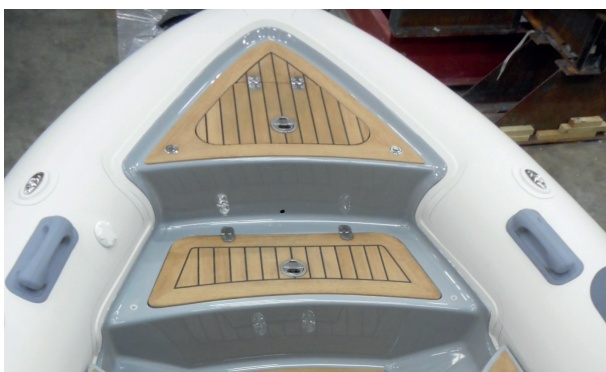
Foredeck restored

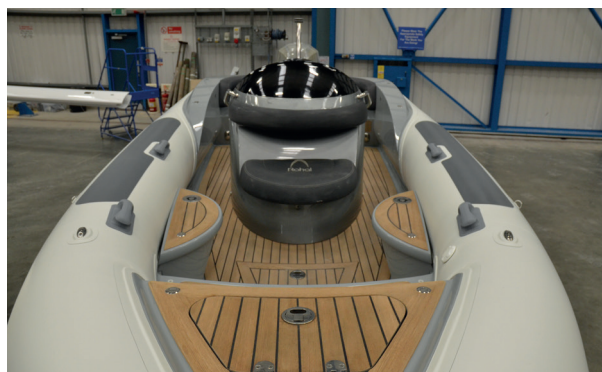
High-quality finish

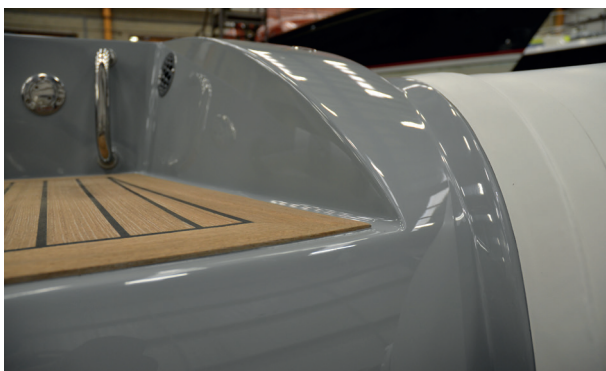
Finished paint and teak deck

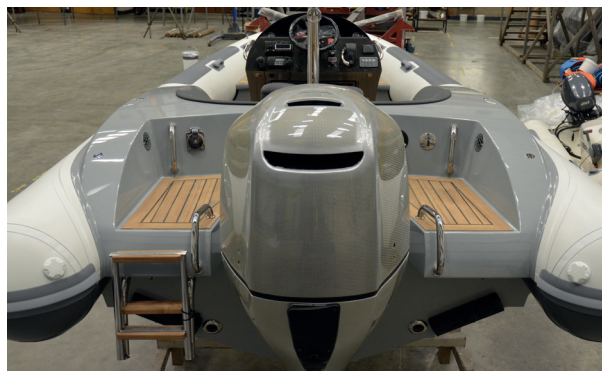
Showing restored brightwork
