— GRAND BANKS 42 REFIT

ROWENA – A 1968 GRAND BANKS 42’

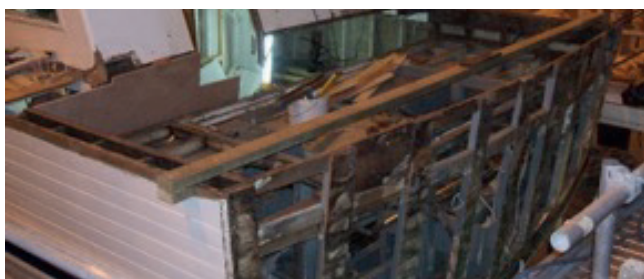
Rotten wood planks removed

Critical accuracy was required for this restoration work. In February this year, the original teak transom planks had to be carefully removed, so that it could be reused following all the repair work scheduled to be carried out, to save ROWENA. Initially, all the topsides were carefully checked at the aft end, and the rotten wood and sections of planks removed over the winter. Then the rebuild began, putting in planks, which needed to be tapered into the chine to fit the existing transom. Painstaking accuracy and time to fair the sections into the stern of the boat, gave the skilled team at Berthon a challenge. Their hours of work paid dividends.

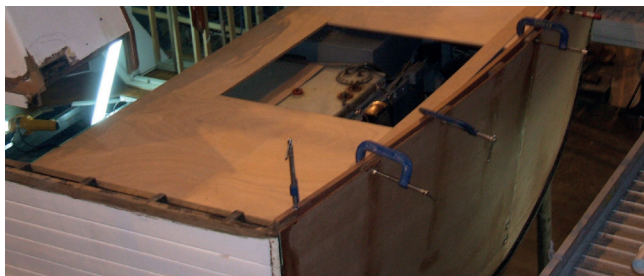
Rebuilding the transom

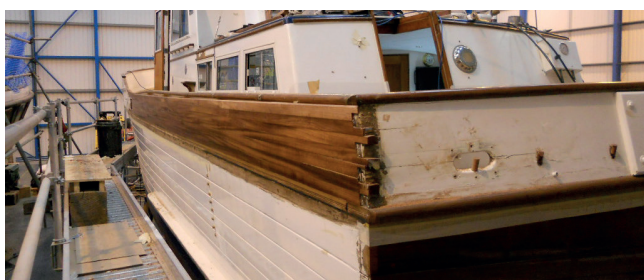
Topside rebuild

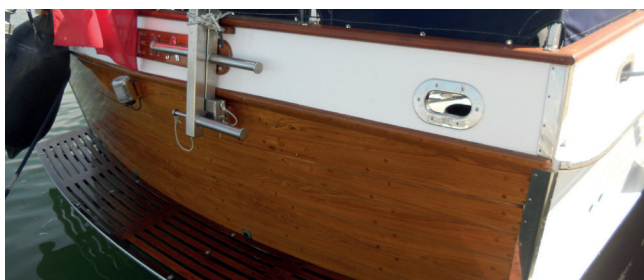
Varnished and painted transom

Finally, when the topside work was complete and the new hull structure was sound, the delicate realignment of the original teak transom began at the end of April. It fitted perfectly first time!

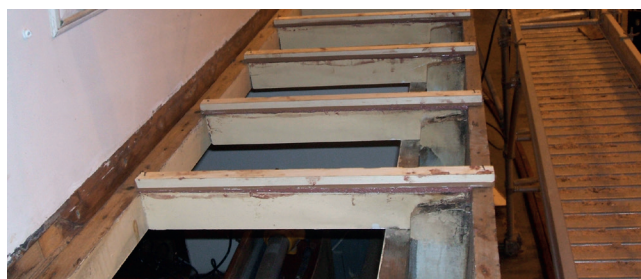
When the team of experts at Berthon came to start work on the new teak decks, they were dismayed to find that there was extensive rot in the sub decks. Therefore all the rot had to be removed section by section and rebuilt, before the new teak deck could be laid.

Sidedeck teak planks removed

All the capping, bulwarks, decks and sub decks had to be removed and rebuilt before the final finish and deck could be laid.

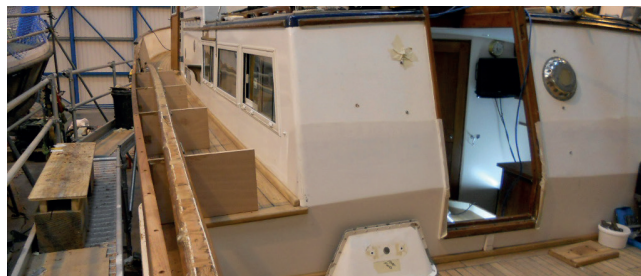
New teak laid

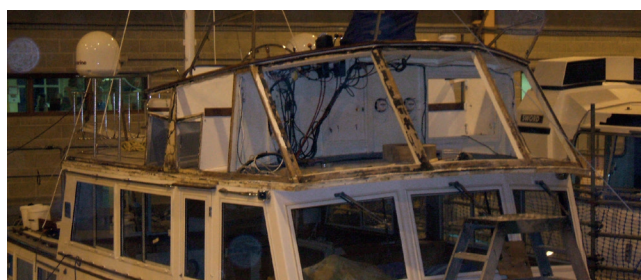
Similar finds of extensive rot, reproduced throughout the superstructure and flybridge.

Removing rotten wood from flybridge and superstructure

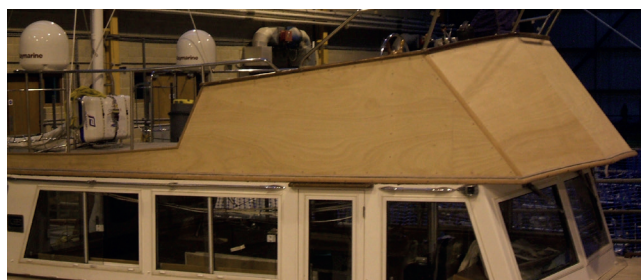
Rebuilt flybridge and superstructure

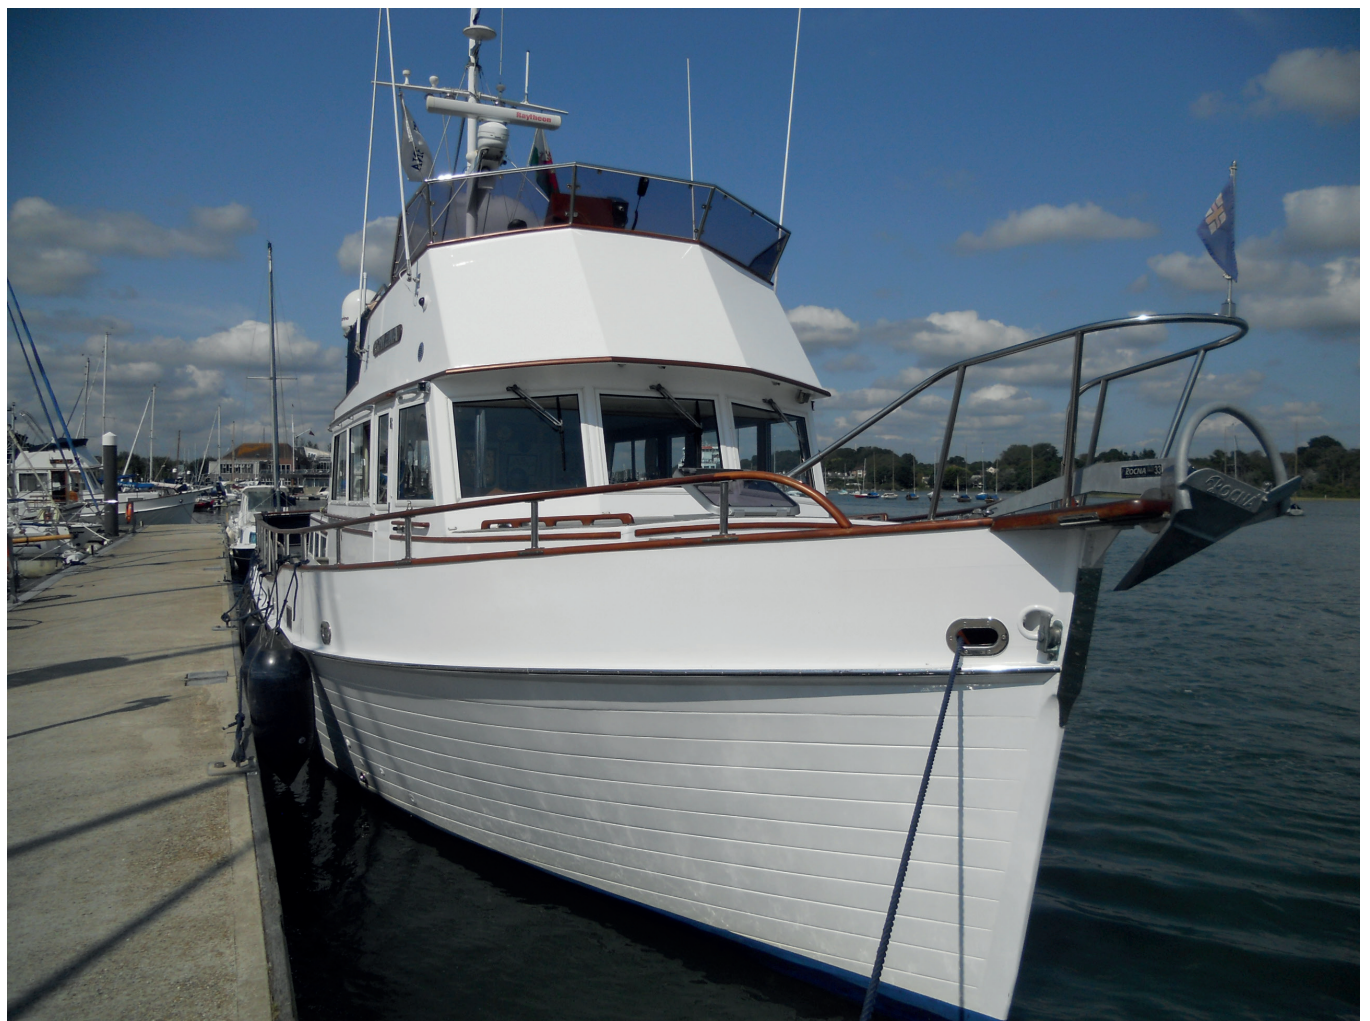
The varnish work on the original transom is a work of art, with ROWENA's name beautifully restored.

Painting of the hull and superstructure to the flybridge, following all the restoration work is now complete and ROWENA is back on the water, looking as good as she did when she was first launched in 1968.
