# SUPERYACHT TENDER SUPPORT

The superyacht Velsheda runs a number of tenders. We received their Novurania 4.3m RIB within 24 hours of the yacht arriving in the UK for a refit. The RIB was showing obvious signs of wear and tear to the exterior. Berthon's in-house team of skilled employees immediately went to work, performing a complete set of repairs and refurbishments.

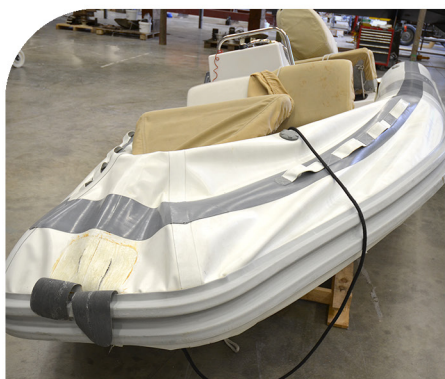
A simple inspection showed that both the port and starboard chambers were compromised with a rip down both sides. Tube repairs were made to both the aft sponsons under the tube and the rubbing strake. Once tube repairs were complete it was given a full solvent wash making it look as good as new.

TUBE DAMAGE TO THE BOW

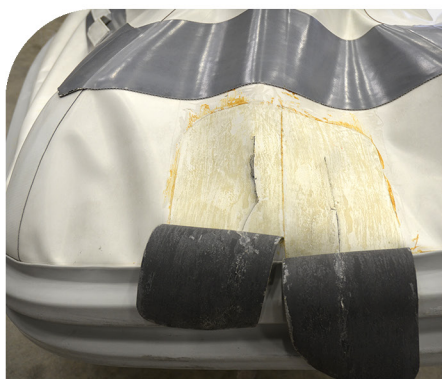
BOW TUBE DAMAGE

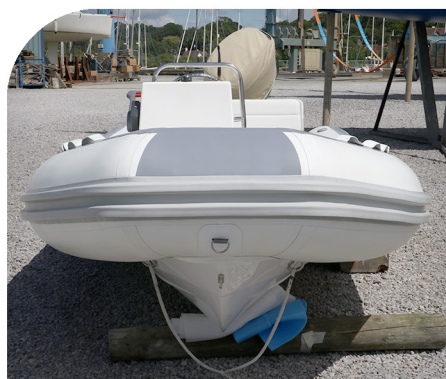
BOW TUBE REPAIR

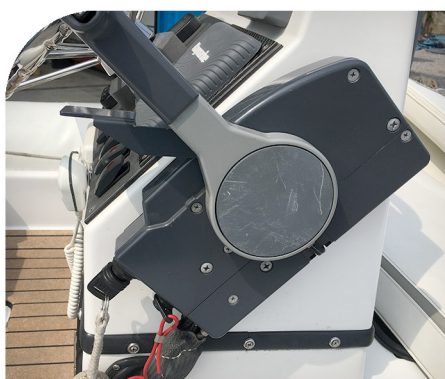
Part of the instructions from the Captain Engineer included the need to investigate throttle problems. Berthon's diagnosis was that the gears had excessive wear and other components were not functioning correctly. The in-gear anti-start mechanism was temperamental causing problems when starting the boat. Estimating the cost of repairs to the throttle system established that replacement would be a more cost-effective solution, and so a new modern 2016 Yamaha compatible unit was installed.

WORN OUT YAMAHA THROTTLE

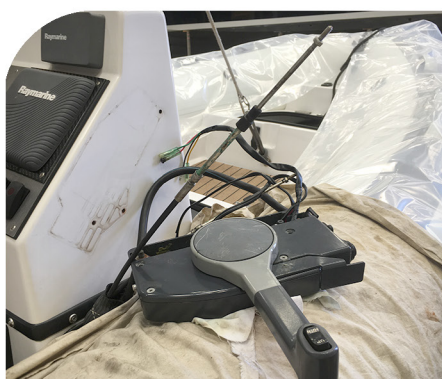
REMOVAL OF THE THROTTLE

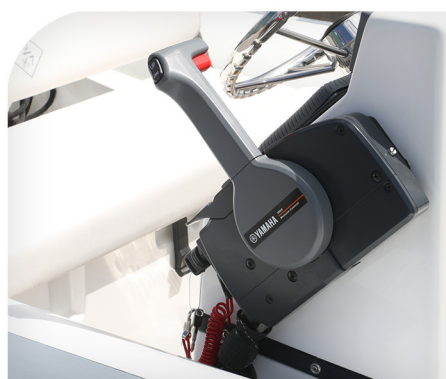
NEW YAMAHA THROTTLE IN PLACE

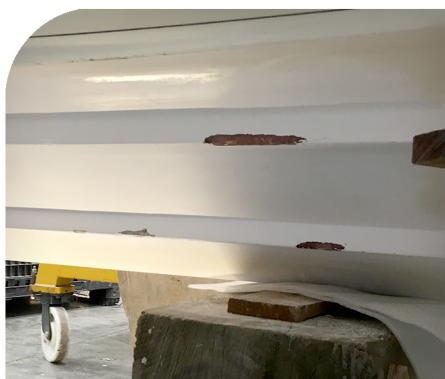
Where the RIB had been repeatedly beached the gelcoat was understandably worn and damaged; these areas were carefully ground back, and matched-colour gelcoat was applied and sanded. UV light and pollution had taken its toll elsewhere, so all the gelcoat both above and below the waterline was cut and polished to create a uniform original colour with repairs imperceptible.

HULL DAMAGE AFTER BEACHING

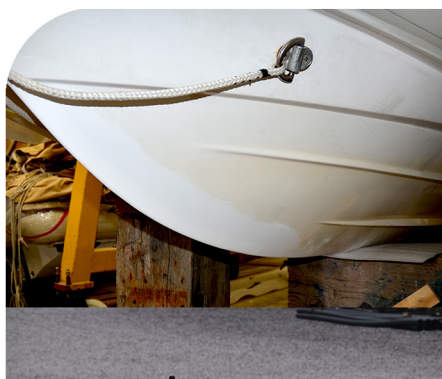
GELCOAT SHOWING REPAIRS

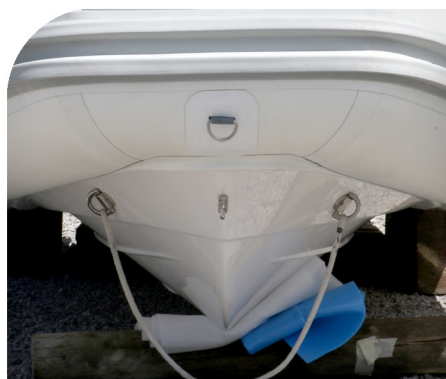
POLISHED GELCOAT REPAIR

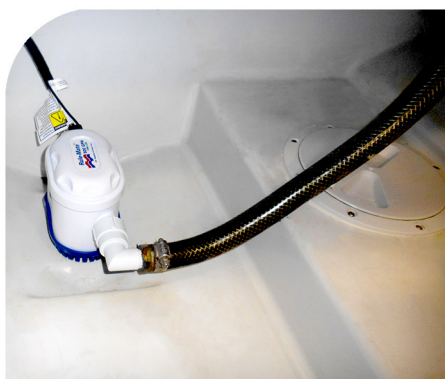
NEW BILGE PUMP

The crew were aware that water was penetrating the hull, and requested two inspection hatches that allowed swabbing the little amount of water left after the new automatic bilge pump we had installed had operated.

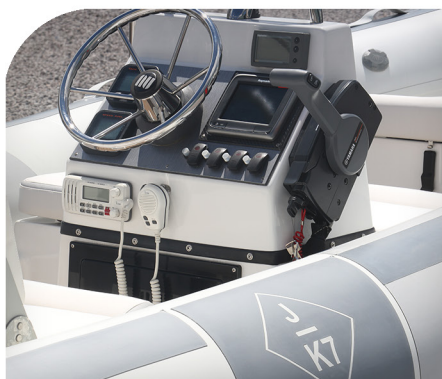
CONSOLE CLEANED AND POLISHED
