PILOT BOAT REFIT

PROVIDENCE – 48FT PILOT BOAT

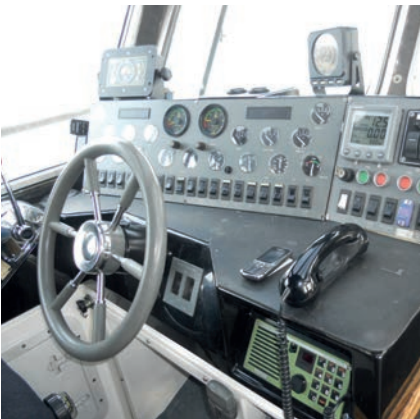
Original helm station

- The Helm and crew consoles were remodelled to include brand new Raymarine electronics along with new Scania engine displays. With this came an extensive rewiring of the boat.
- Kobelt electronic engine controls were fitted to control the new Scania engines in the existing morse lever control area. This affords more precise throttle control over traditional cable systems whilst maintaining the coxswains favoured ergonomic layout of the helm console.
- All of the deck head panels were removed, reinsulated and carpeted.
- Wheelhouse glazing (x19 windows) were all removed, replaced or reconditioned.
- The old cab seats (x8 seats) were removed and replaced.
- Trim panels were repaired and replaced.
- Any exposed woodwork was removed and varnished.
- Fire control panel was reworked and relabelled.

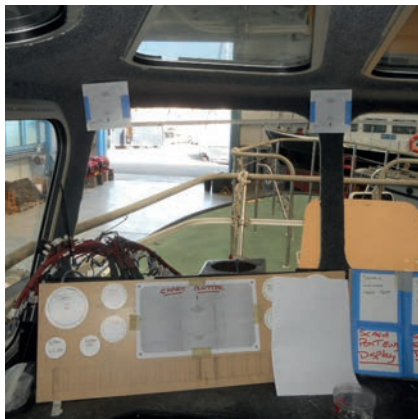
Template testing

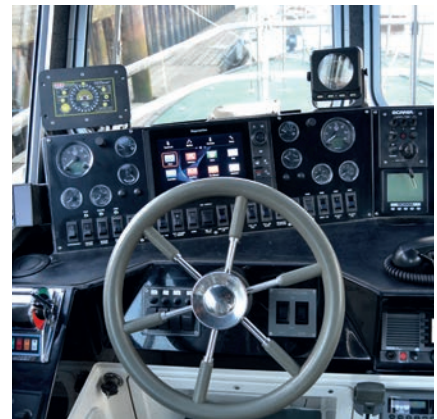
New modern helm station

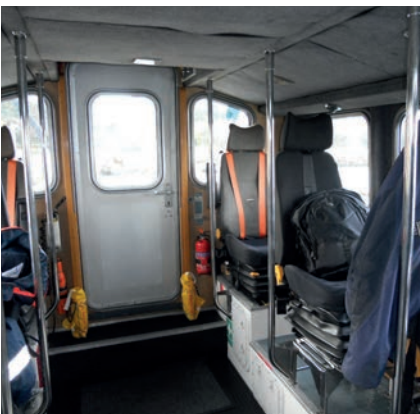
Interior prior to removal

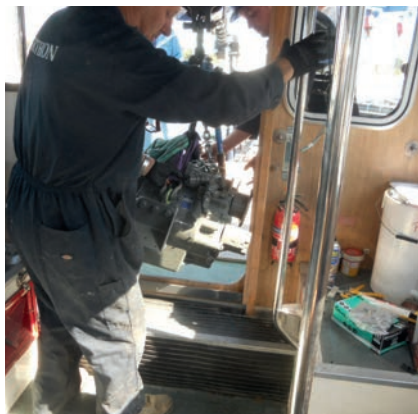
Stripped out

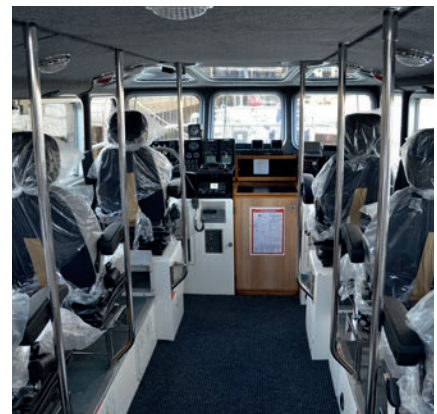
New interior

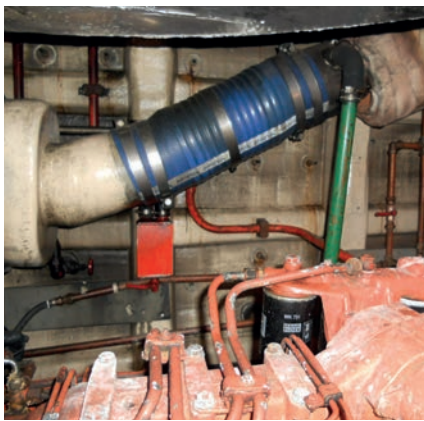
Original engine looking tired

The original, and now unreliable, Scania D14's were removed early on so that the engine room bilges could be drained of any residual water and oil. The bilges were then cleaned, repaired and repainted. For ease of access, many of the detailed overhaul and repair jobs were carried out after the engines were removed. New hydraulic pipework and the steering overhaul were among other jobs completed at this time.

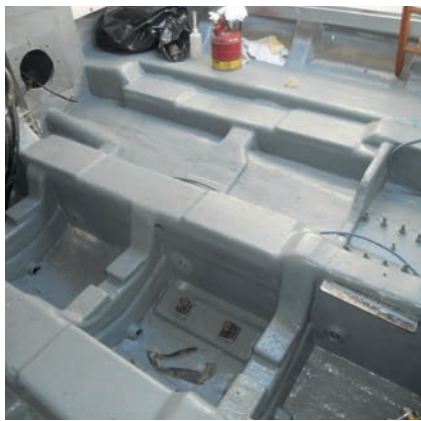
Engine bay ready for engines

The main longitudinal stiffeners, which provide the engine foundations, were cut out and remodelled to accept the new engine and gearbox geometry, ensuring a perfect alignment was created for the new propeller shafts. Once this was completed, brand new Scania DI13's were fitted. These are not only more powerful than the D14's, but are lighter and more fuel efficient too. In order to transmit the power to the propellers efficiently and reliably, the old gearboxes were removed and fully rebuilt using new parts. They were then refitted at the same time as the engines.

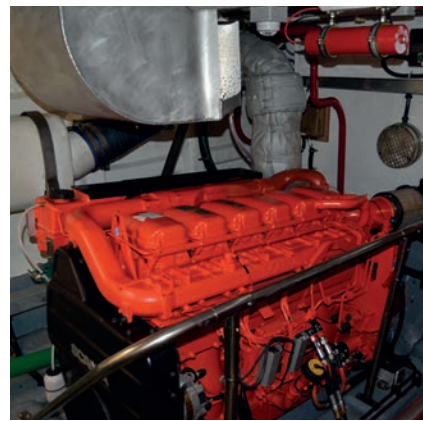
New port engine in place

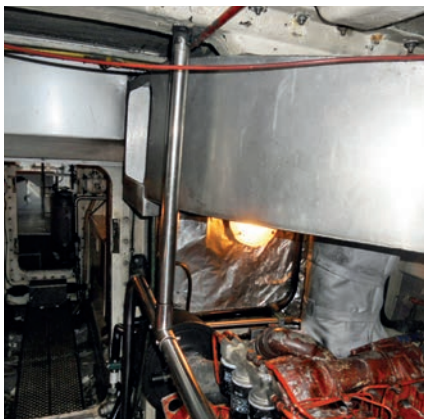
Old engine room ducting

One of the major redesign jobs Berthon carried out was the rearrangement of the engine room ventilation system. The original 'factory' fitted trunking was very large, taking up too much space. This allowed too much sea water spray into the machinery space which led to salt contamination, corrosion and electrical problems. Berthon overcame this by fitting Premaberg mist eliminator filters and resizing and redirecting the vent trunking. Also, more powerful fans have been fitted to lower the operating temperatures inside the machinery space. This allows the engines to run more efficiently.

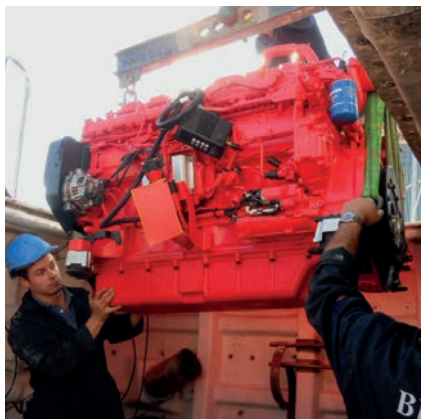
New Scania DI13 engine

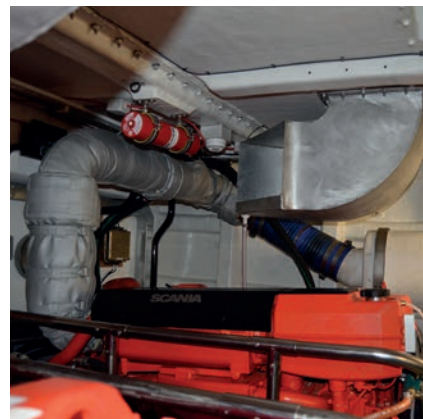
New ducting and engine

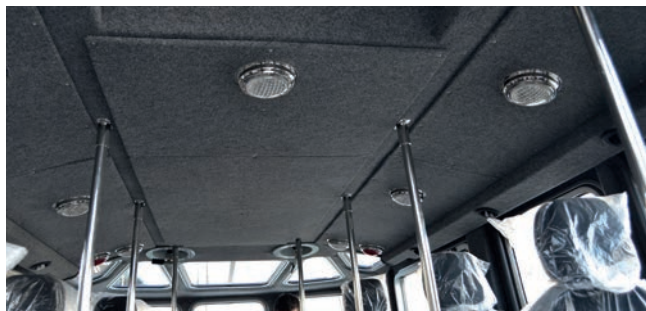
Insulated deckhead panels

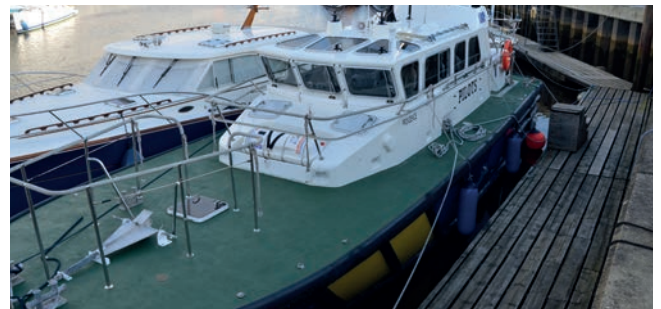
Gleaming superstructure

- Mast removed, stripped and repainted.
- New Navigation and signal lights fitted.
- New remote controlled search lights fitted.
- Antenna and radar mounts refurbished and refitted.
- New GPS and radar antennas fitted.
- Full polish of the superstructure and any damage repaired as required.

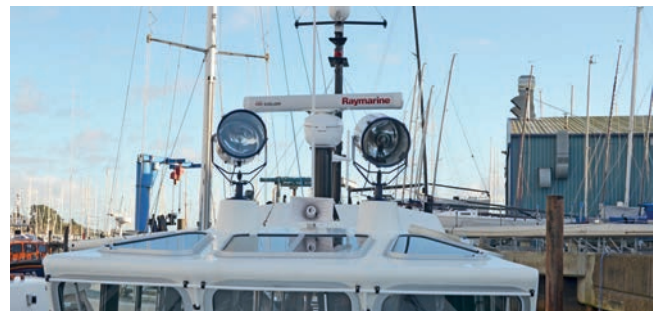
Navigation and search lights
